# Virgin Islands Shipping & Maritime Authority

## **NAVIGATION WARNING** **NOTICE TO MARINERS No. 03-2025 (T)**

**EXTINGUISHED LANTERN AT MOUNTAIN POINT VIRGIN GORDA.**

**MOUNTAIN POINT- VIRGIN GORDA- 18-30.181' N 64-24.947'W**

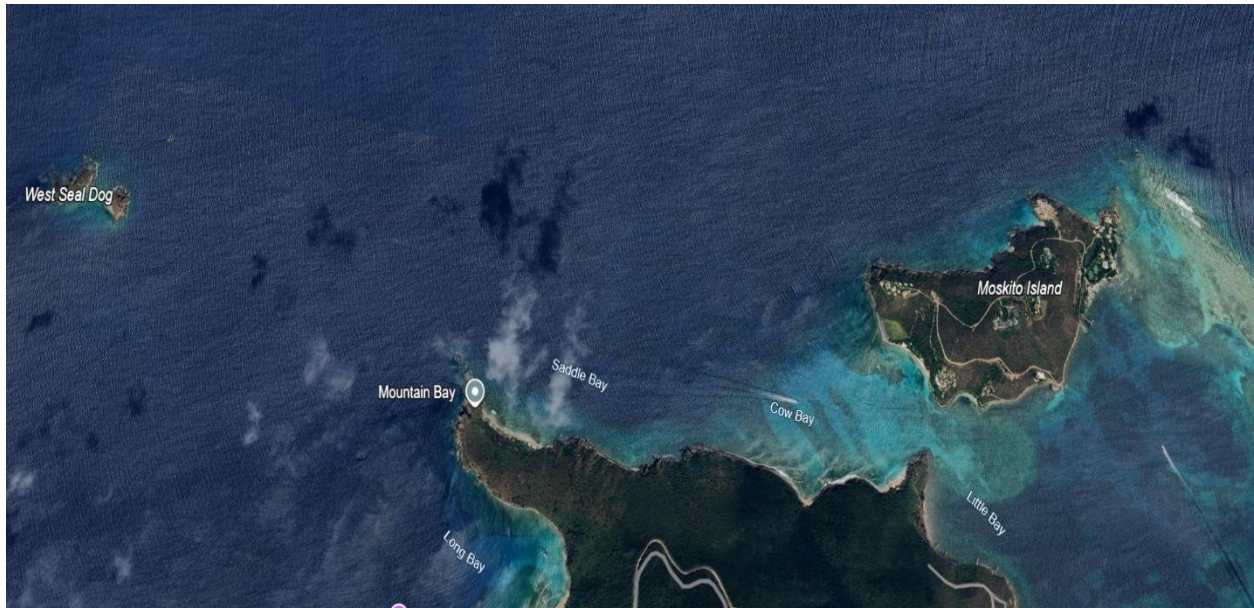
Mariners are advised that the Mountain Point Light has been reported extinguished and is currently not operational.

This light serves as a key aid to navigation, marking the north-western entrance to the Virgin Gorda channel, between northern coast of Virgin Gorda and Mosquito Island. Its absence affects the night-time visibility of the coast, unsubmerged rocks and other

dangers, increasing the risk of grounding and close-quarter situations in the vicinity.

- **Plot courses well clear of Mountain Point, while transiting along the north and north-western coasts of Virgin Gorda.**
- **Navigate with extreme caution in the area, particularly during night hours and periods of restricted visibility.**
- **Vessels without operational radar should avoid transiting the area at night or in periods of restricted visibility.**
- **Vessels with operational radar should also maintain a sharp lookout by sight and, in any case, pass well clear of the Cow Mouth rocks.**
