NAVIGATION WARNING NOTICE TO MARINERS No. 05-2025 (T)

REPORTED INCIDENT OF NAVIGATIONAL BUOY BREAKAWAY

LONG BAY, BEEF ISLAND, BRITISH VIRGIN ISLANDS VG 18-27.194N 064-32.365W

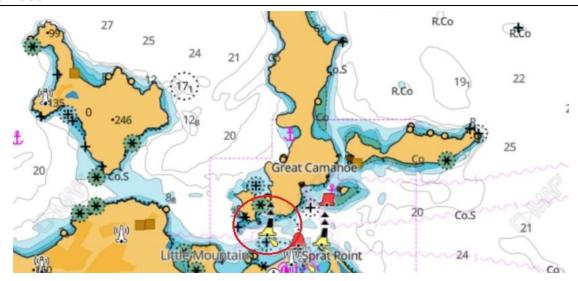
Mariners are advised that the **Long Bay North Cardinal Marker**, which marks a **submerged rock**, has broken free from its station and is currently **missing from its charted position**.

This cardinal mark is a critical aid to navigation, marking the presence of a submerged hazard in the long bay area. The absence of this buoy poses a **significant risk to safe navigation**, particularly in low visibility or for vessels unfamiliar with local waters. All mariners are urged to:

- Exercise extreme caution when navigating in this area, and
- **Keeping safely North** of the charted coordinates of the north cardinal maker.

Efforts are currently underway to recover and re-establish the buoy. A follow-up notice will be issued once this navigation aid is restored.
