# Virgin Islands Shipping & Maritime Authority

## **NAVIGATION WARNING** **NOTICE TO MARINERS No. 02-2025 (P)**

**REPORTED INCIDENT OF NAVIGATIONAL BUOY BREAKAWAY**

***OYSTER ROCK BRITISH VIRGIN ISLANDS VG 18-29.667N 064-21.829W***

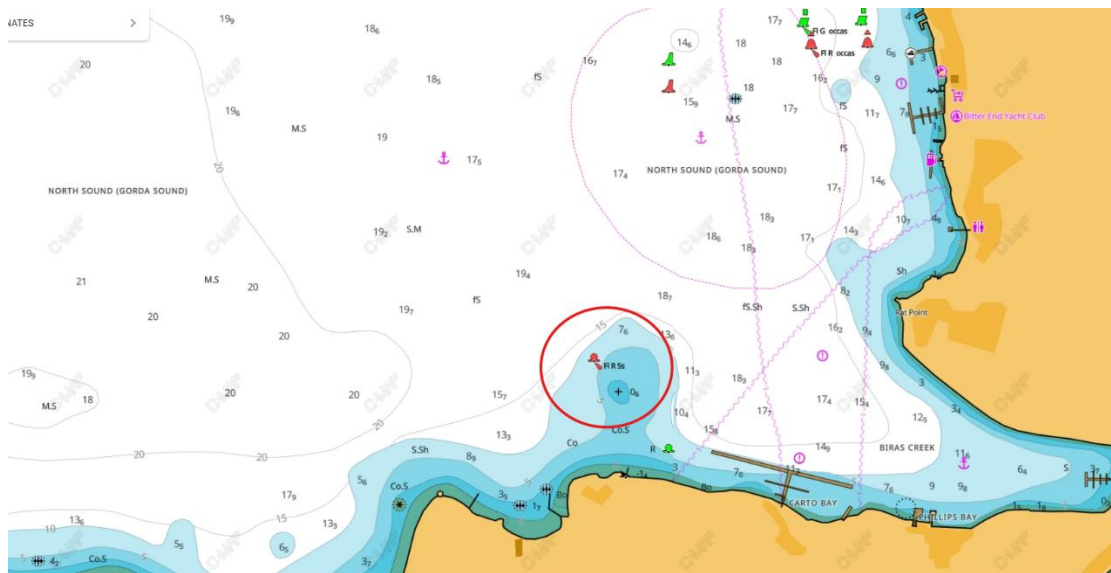
Mariners are advised that the **Oyster Rock Red Buoy**, which marks a **submerged rock**, has broken free from its station and is currently **missing from its charted position**.

This red buoy is a critical aid to navigation, marking the presence of a submerged hazard in the north sound area. The absence of this buoy poses a **significant risk to safe navigation**, particularly in low visibility or for vessels unfamiliar with local waters.

- **Exercise extreme caution** when navigating in this area, and
- **Avoid direct passage** over the charted coordinates.

Efforts are currently underway to recover and re-establish the buoy. A follow-up notice will be issued once this navigation aid is restored.
