MARINE SAFETY ALERT

Safety Alert 04-23

INFLATABLE BOAT SAFETY: DO NOT OVER-PRESSURIZE!

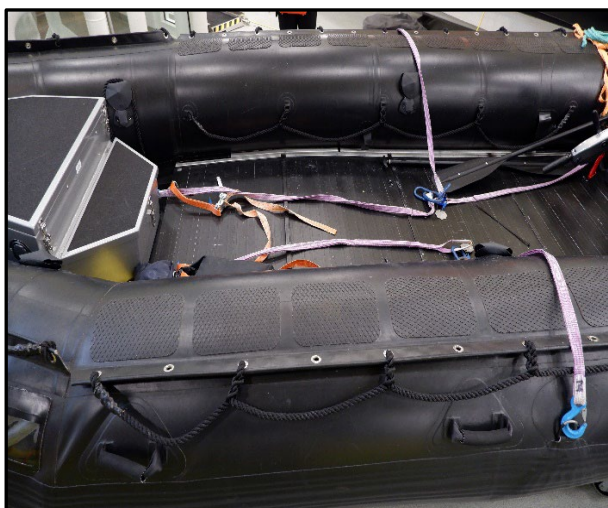
Figure 1 -Zodiac after bladder failure. Deformation to the deck is visible.

During a recent investigation of an incident that occurred involving foreign cruise vessel operations in the Antarctic, a U.S. passenger was severely injured due to a Zodiac MILPRO model FC 580/MK5 keel bladder failure while underway on a sightseeing excursion. In calm weather, the keel bladder suddenly ruptured, sending the passenger several feet into the air before landing onto the deck and sustaining serious injuries including a fractured femur. Another passenger was thrown overboard into the freezing water, risking hypothermia.

The Coast Guard **strongly recommends** that operators of cruise ships and other companies employing inflatable boats:

- Review all manufacturer recommendations for inflatable boat filling and maintenance to verify those procedures are being followed prior to any boat operations including passenger excursions.
- Use manufacturer recommended inflation devices (e.g., a foot pump) and appropriate pressure measurement tools to avoid over-pressurization.
- Verify that company policy addresses manufacturer recommendations and that crews are properly trained before operating and performing maintenance on inflatable boats.
- Contact the manufacturer of your inflatable boats for any additional recommendations and/or training options they may offer.

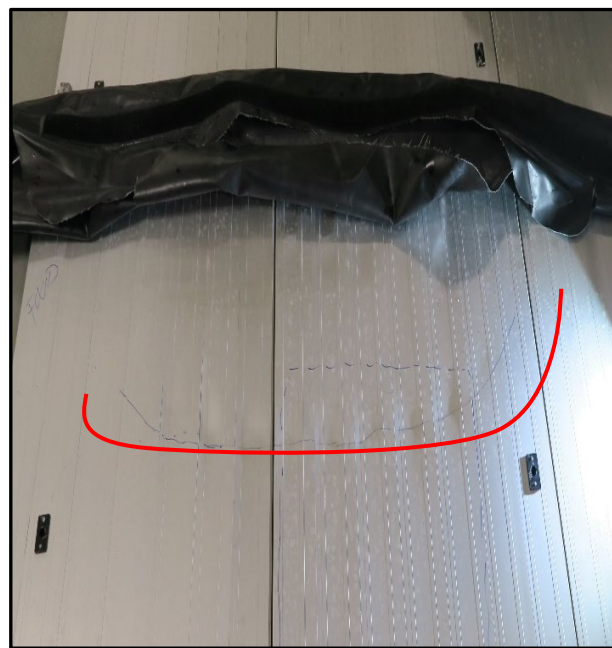
An investigation has identified that the keel bladder suffered a rupture due to excessive pressure in the tube. The recommended operating pressure by the manufacturer is 3.4 pounds per square inch (p.s.i) or 240 millibar pressure (mb). An on-scene survey of multiple inflatables on board the cruise ship noted pressures up to and exceeding 9 p.s.i. (620 mb) in other keel bladders. The keel bladder is not protected by a safety relief valve, and the manufacturer recommends that they be inflated with a foot pump to reduce the chance of over-pressurization. However, crewmembers were routinely using an air compressor to fill the buoyancy chambers (including the keel tube) prior to the incident. In addition, pressure levels were not being checked using a manometer as recommended by the manufacturer.

Figure 2 – Ruptured keel bladder and the view of the underside of the metal hull. The red line has been added to highlight the deformities in the hull metal due to the keel bladder rupture.

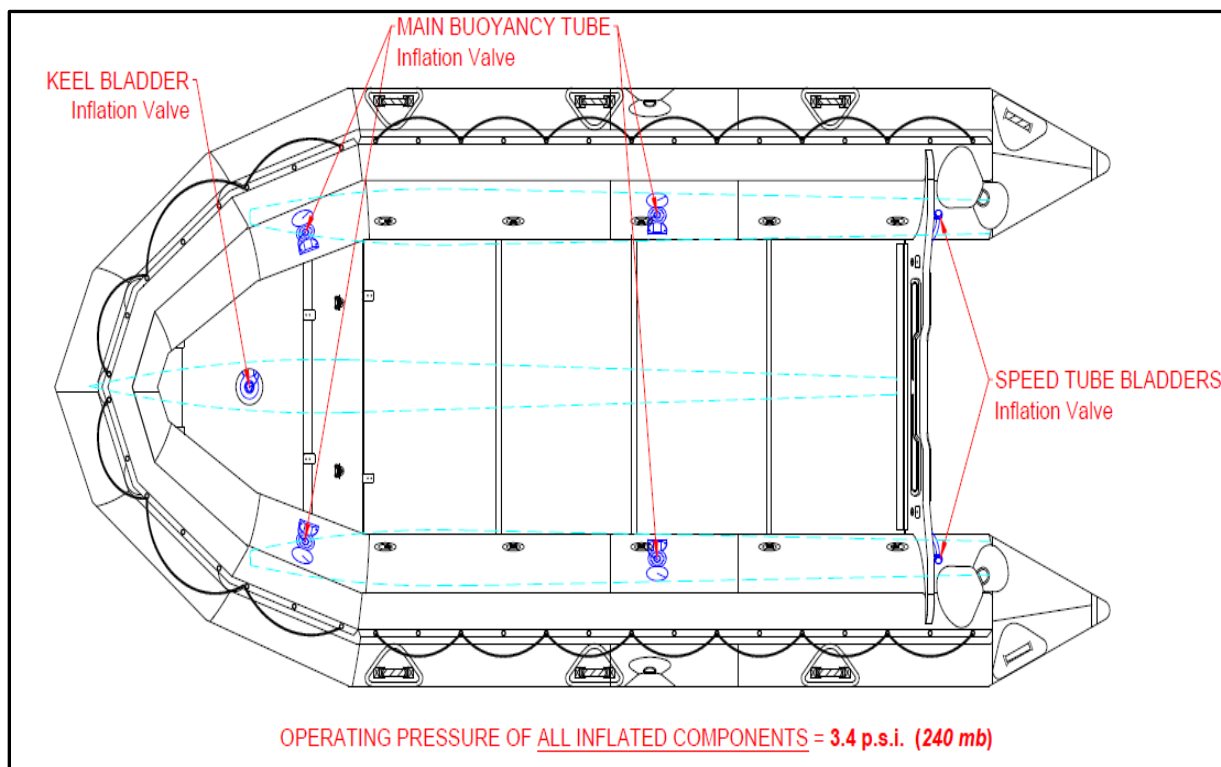
Figure 3 – Diagram of Zodiac MILPRO.
